MJ11/MM11

TECHNICAL
INFORMATION
COMPANY CONFIDENTIAL

EP MJ11 TI D

DEC 1977
MADE IN USA

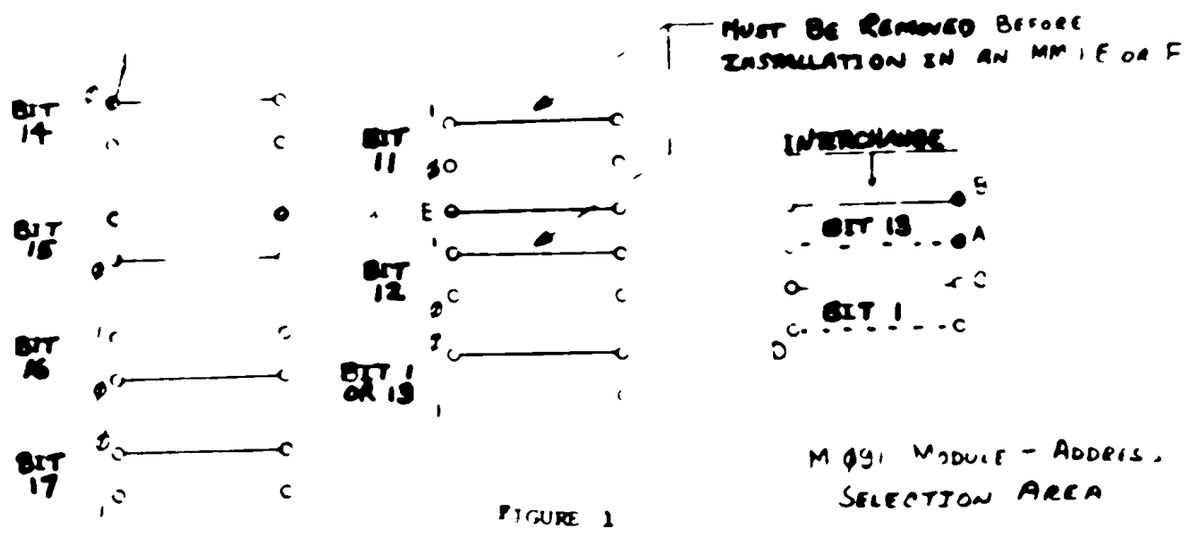
FIGURE 1

MM11-F interleaving is accomplished by manipulation of jumper wires on the M1091 module. These changes are shown in Table 1. It is a normal procedure for the production line to interleave all 8K segments of MM11-F memory on the initial system prior to shipment.

Interleaving of a MM11-E with an MM11-F is not recommended primarily due to the confusion it creates when troubleshooting a system of this nature. It also creates customer misunderstanding since the average memory cycle time specification, in this situation, would not be either the MM11-E or F but somewhere in between.

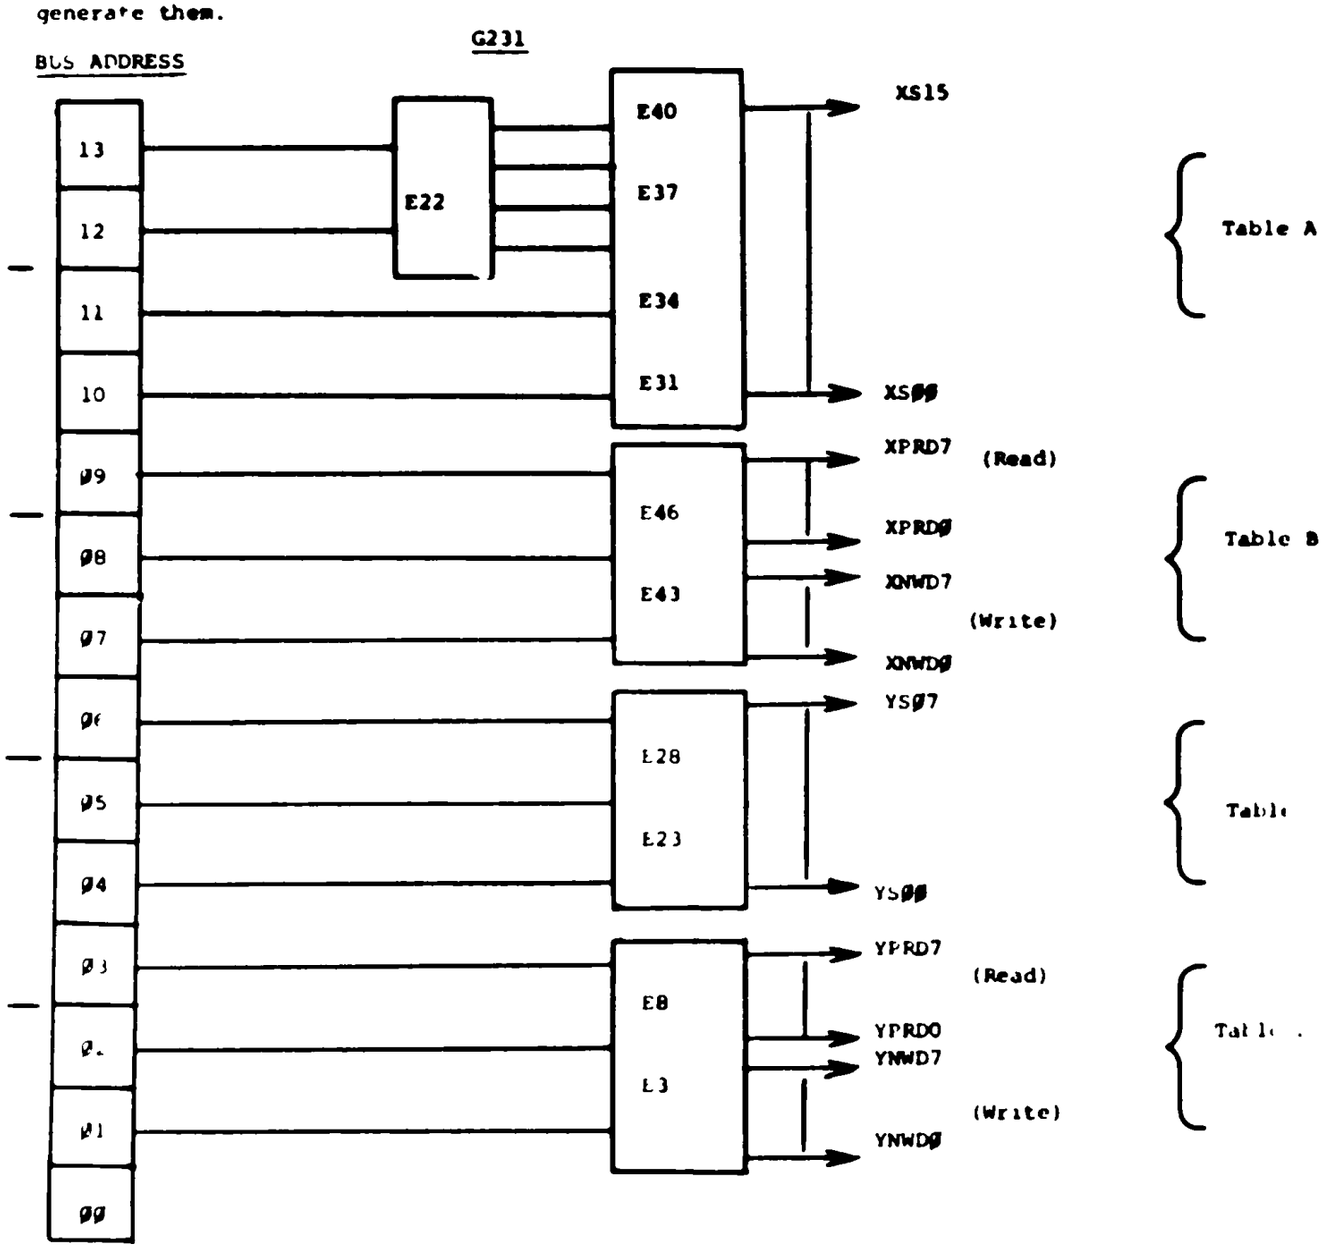
The diagram and tables supplied here are to aid F/S men when they are troubleshooting MM11L, S & K memories by relating the drive signals on the G231 with the addresses that generate them.

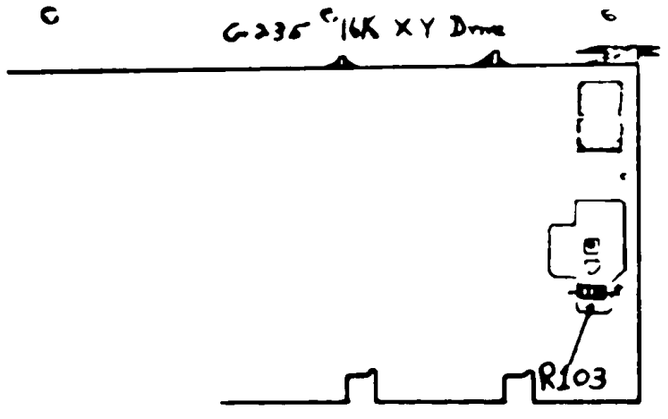
Many reports have been received from the field concerning memories failing high current margins and module set incompatability (i.e. unable to swap modules). Investigation has shown that the inhibit margins are not properly centered, which could cause marginal operation of the memory under conditions of high drive currents. An ECO (G235-0009) was generated to correct this problem.

1. Place G235 component side up and fingers toward you.
2. Look at right hand side of module in large etch area (see drawing).
3. If resistor R103 (75Ω 1W) which is across bottom of large etch is not in, ECO has not been installed.

This ECO should be installed before attempting massive module swap or option swap.

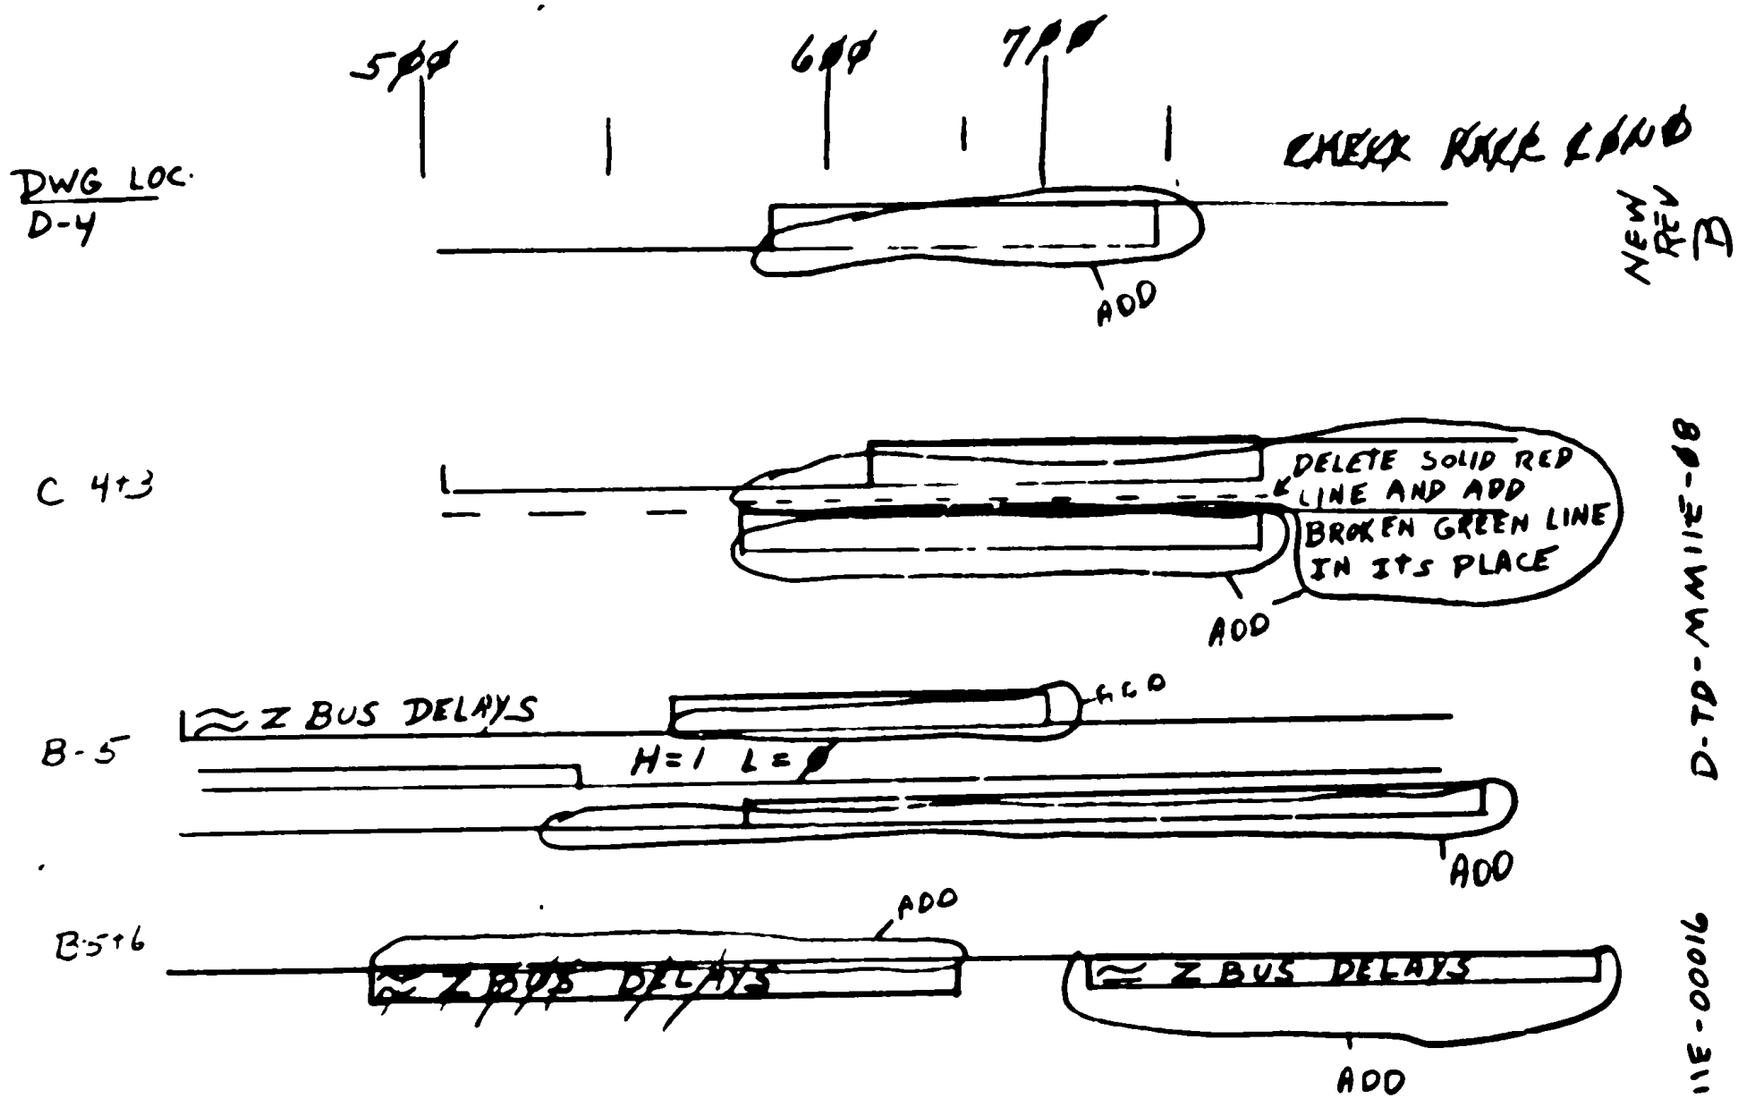
5ØØ
6ØØ
7ØØ
CHECK ROCK LAND
NEW REV B
ADD
DWG LOC.
D-4
C 4+3
DELETE SOLID RED LINE AND ADD BROKEN GREEN LINE IN ITS PLACE
ADD
B-5
≈ Z BUS DELAYS
H=1 L=Ø
ADD
B-5+6
ADD
≈ Z BUS DELAYS
≈ Z BUS DELAYS
ADD
ECO # MM11E-00016
D-TD-MM11E-00

LENGTH SHOULD BE A MAXIMUM OF 2¼ INCHES. CHECK DRAWINGS FOR LENGTH AND FOR HOW LOOPS SHOULD BE DRESSED INTO LOGIC.

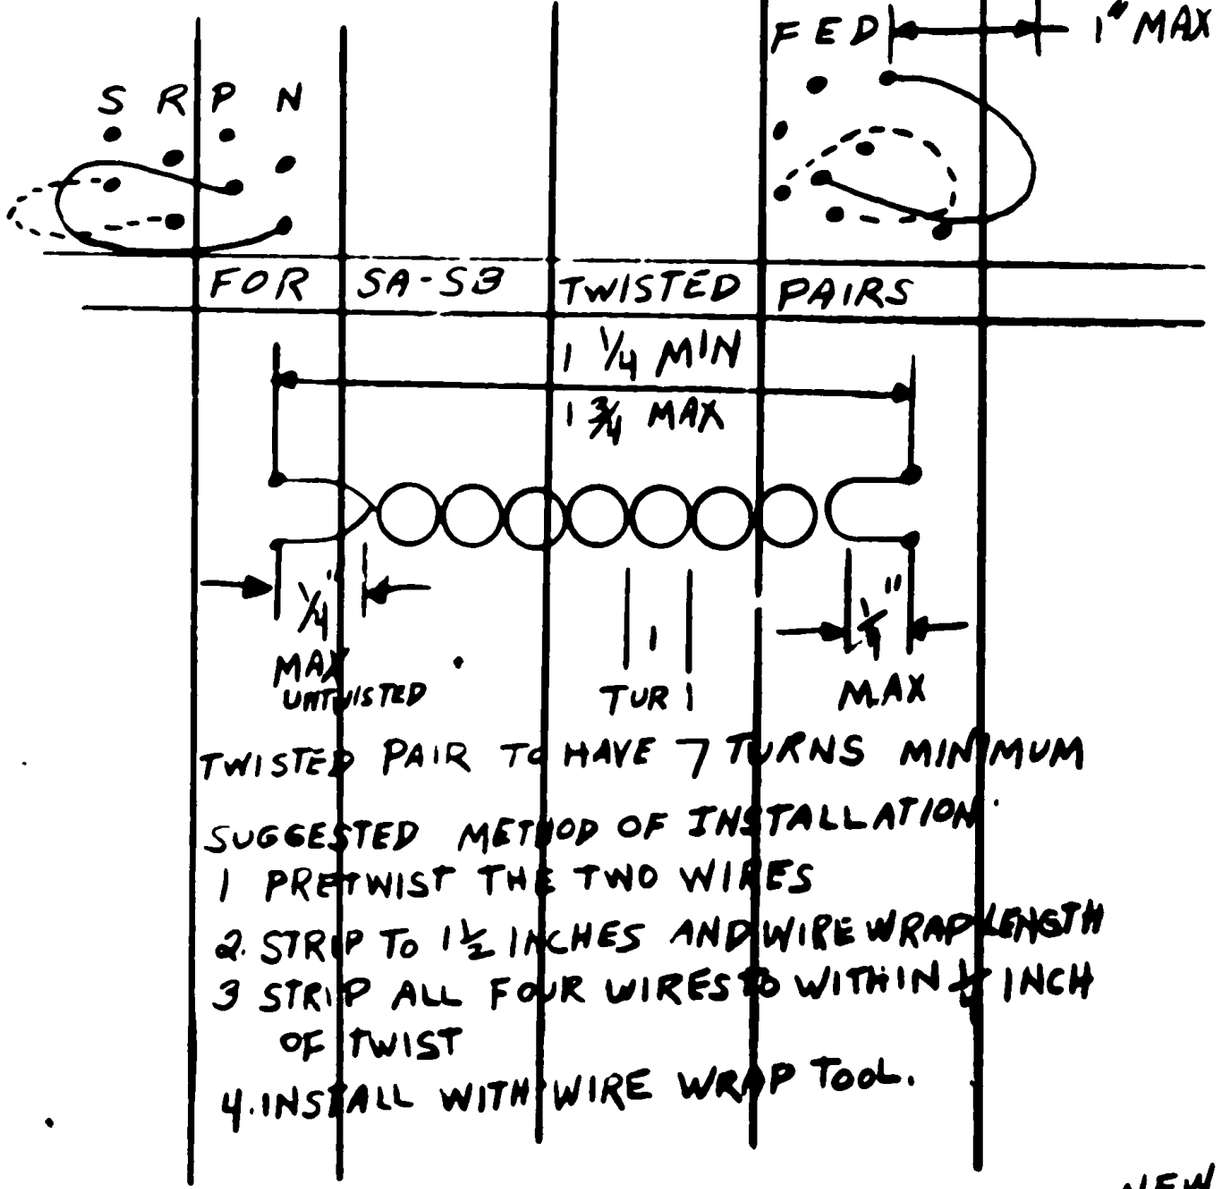
TWISTED PAIR TO HAVE 7 TURNS MINIMUM

SUGGESTED METHOD OF INSTALLATION:

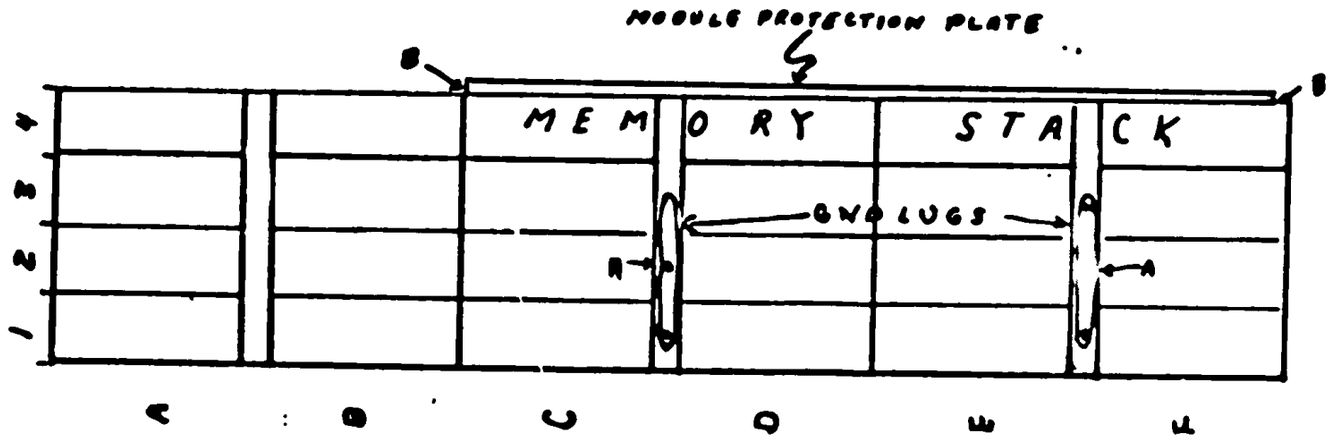
SHEET 2 OF 2

Under some conditions when other options are placed along side an MM11/E they fail to operate correctly.

1. Carefully install module protection plate per FCO instructions. This requires insertion of the plate under existing wire runs which are easily broken.
2. Run maindecs or other programs whose failure indicated the need for this FCO to be implemented. They should now function correctly.

1. LOOSEN 2 SCREWS AT POINTS A. CARE SHOULD BE USED AT ALL TIME SO THAT NO WIRES WILL BE DAMAGED.
2. SLIDE THE FINGERS OF THE MODULE PROTECTION PLATE UNDER THE GND LUGS. THE PROTECTION PLATE SHOULD BE RIGHT AGAINST THE WIRED ASSY. FRAME, POINTS B.
3. TIGHTEN SCREWS.

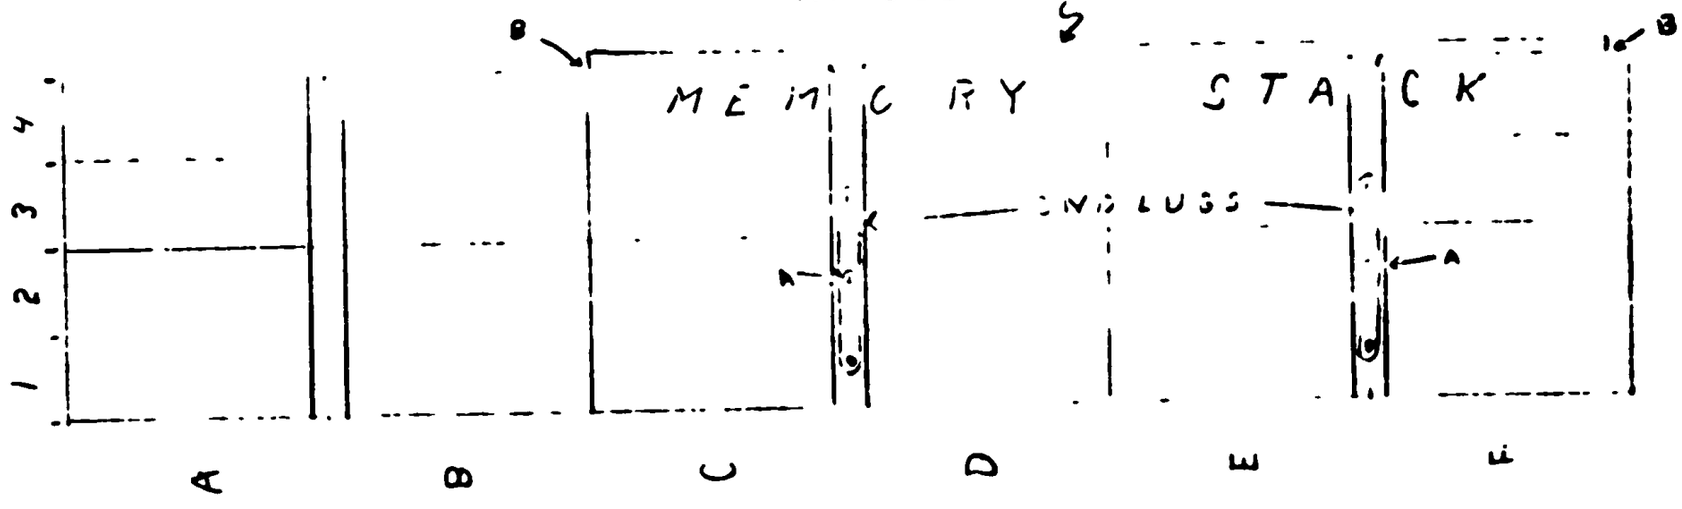
MODULE PROTECTION PLATE

Under some conditions when other options are placed along side an MM11/F they fail to operate correctly.

1. LOOSEN 2 SCREWS AT POINTS A, CARE SHOULD BE USED AT ALL TIME SO THAT NO WIRES WILL BE DAMAGED.

3 TIGHTEN SCREWS.

1. Carefully install module protection plate per FCO instructions. This requires insertion of the plate under existing wire runs which can be easily broken.
2. Run maindecs or other programs whose failure indicates the need for this FCO to be implemented. They should now function correctly.

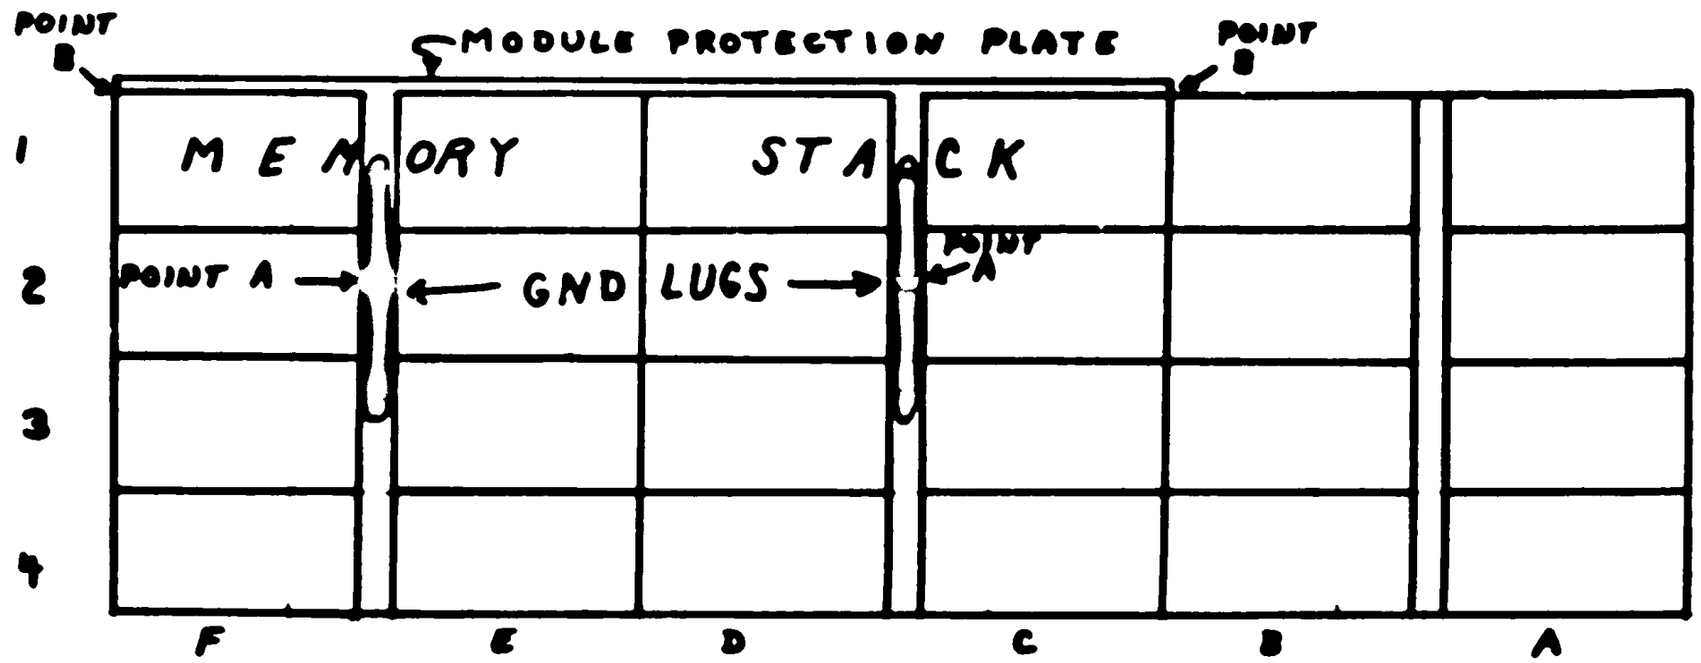
MM11S REWORK SHEET

Under some conditions when other options are placed along side an MM11/S they fail to operate correctly.

1. LOOSEN 2 SCREWS AT POINTS A. CARE SHOULD BE USED AT ALL TIME SO THAT NO WIRES ARE DAMAGED.
2. SLIDE THE FINGERS OF THE MODULE PROTECTION PLATE UNDER THE GND LUGS. THE PROTECTION PLATE SHOULD BE RIGHT AGAINST THE WIRED ASSY. FRAME, POINT B.
3. TIGHTEN SCREWS.
