MM11

TECHNICAL
INFORMATION
COMPANY CONFIDENTIAL

EP-MM11-TI-A
COPYRIGHT © 1978
FICHE 1 OF 1

TECH
TIPS

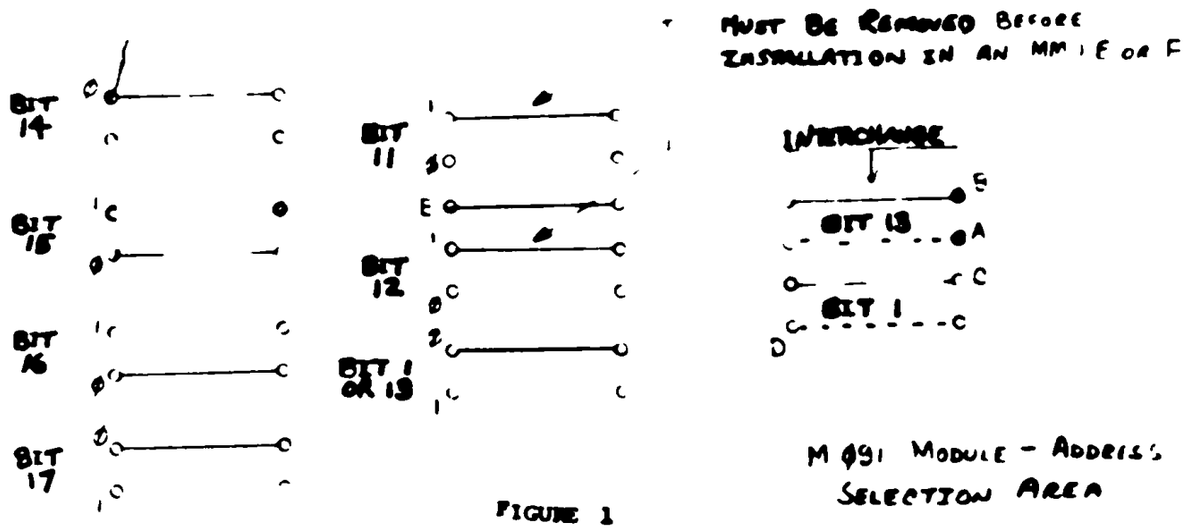
FIGURE 1

Both the M9ll-E and M9ll-F memories now utilize M1Ø91 address selector modules. Figure 2 shows the circuit schematic of the M1091 address selection logic. Figure 1 shows a layout of that portion of the physical module where the addressing is accomplished by insertion or removal of jumper wires. Table 1 lists the following:

d. Bits 17, 16, 15, 14, 13 and Ø1 Non-Interleaved These columns show, by an X, that jumper which should be installed in order to respond to a specific memory bank addressing. The 1, Ø, A, B, C and D correspond to the identification shown on the module, figure 1, and figure 2.

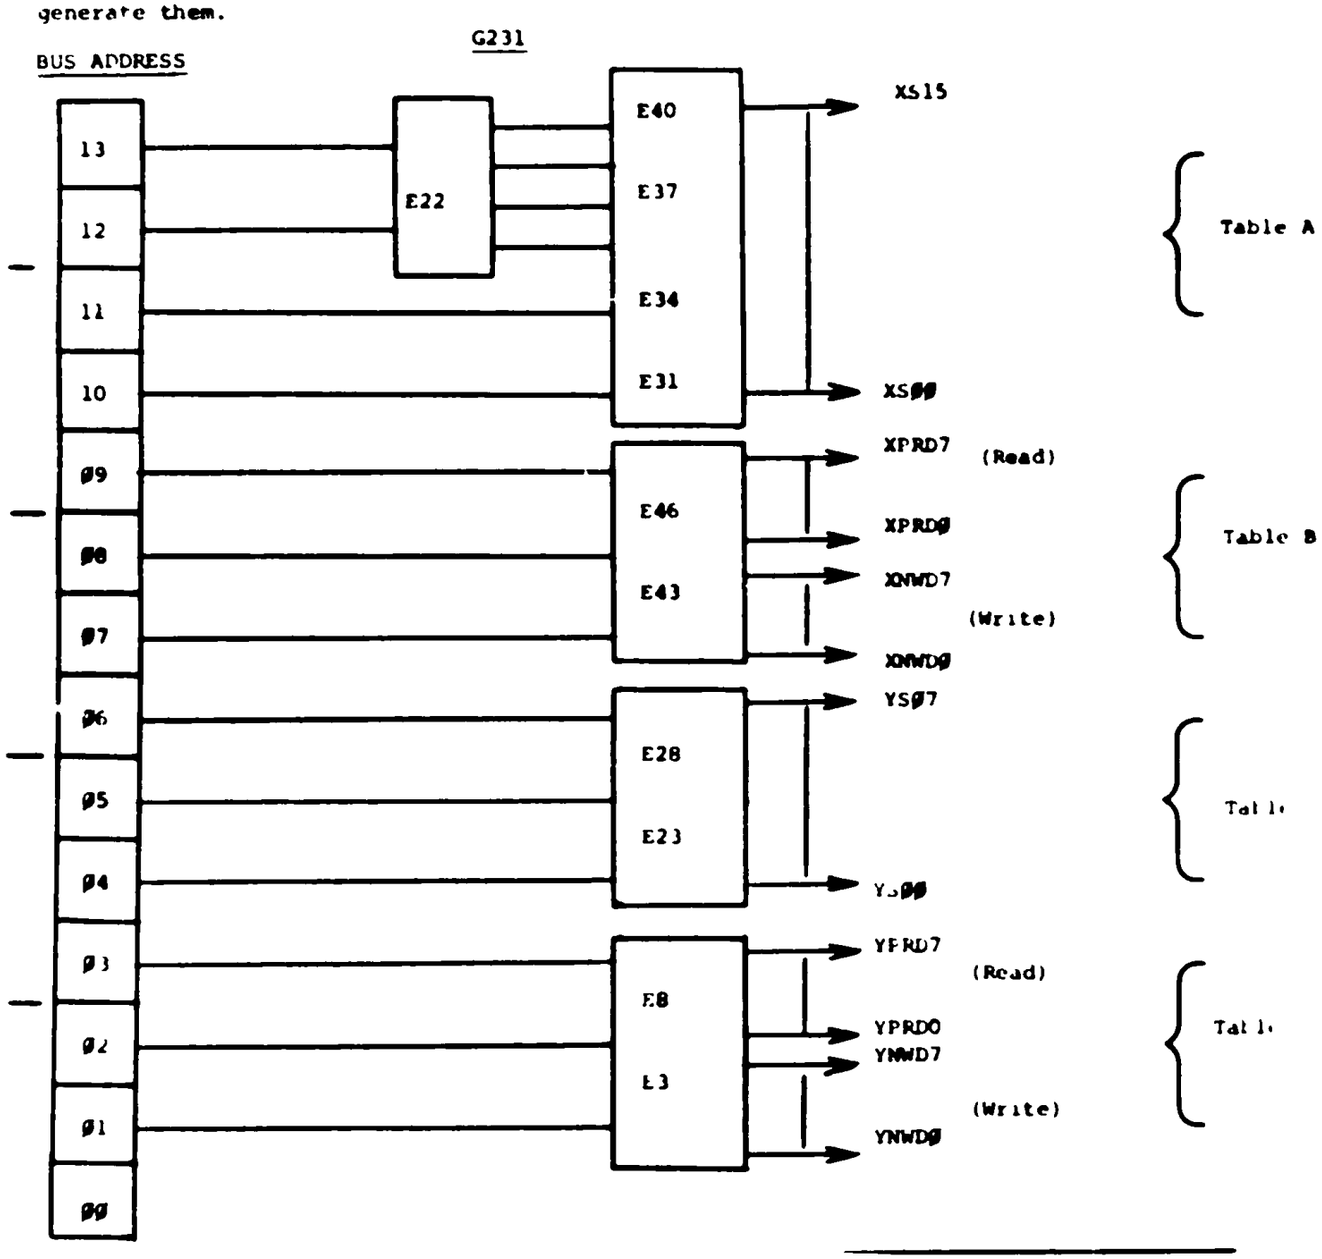
The diagram and tables supplied here are to aid F/S men when they are troubleshooting MM11L, S & K memories by relating the drive signals on the G231 with the addresses that generate them.

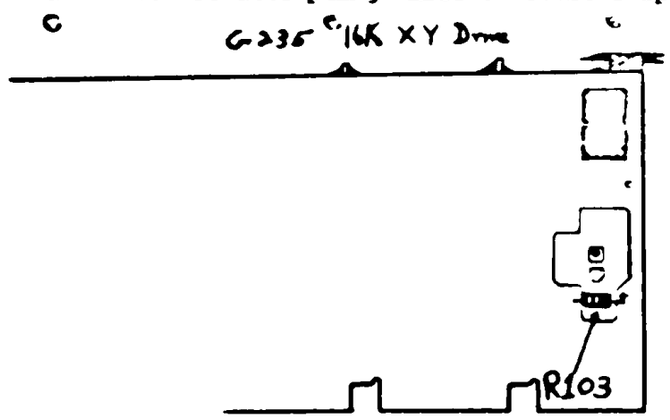
Many reports have been received from the field concerning memories failing high current margins and module set incompatability (i.e. unable to swap modules). Investigation has shown that the inhibit margins are not properly centered, which could cause marginal operation of the memory under conditions of high drive currents. An ECO (G235-0009) was generated to correct this problem.

1. Place G235 component side up and fingers toward you.
2. Look at right hand side of module in large etch area (see drawing).
3. If resistor R103 (75Ω 1W) which is across bottom of large etch is not in, ECO has not been installed.

This ECO should be installed before attempting massive module swap or option swap.

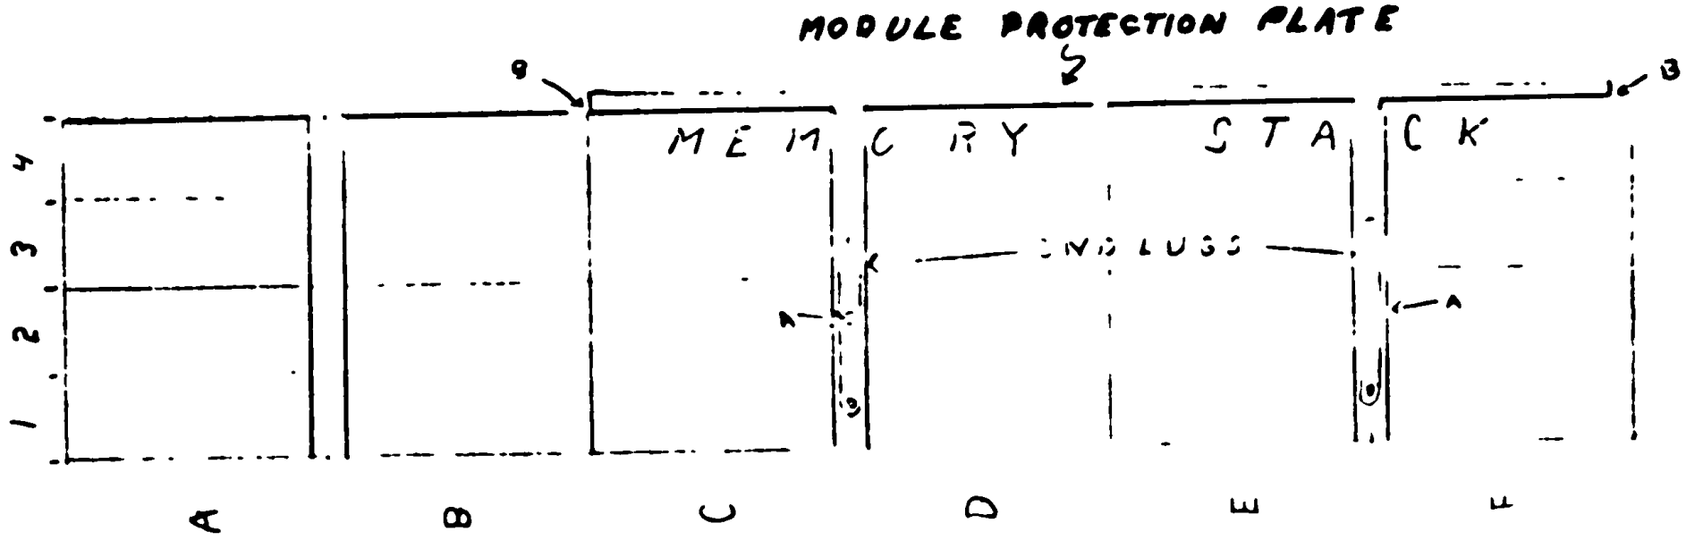
MODULE PROTECTION PLATE

Under some conditions when other options are placed along side an MM11/F they fail to operate correctly.

1. LOOSEN 2 SCREWS AT POINTS A, CARE SHOULD BE USED AT ALL TIME SO THAT NO WIRES WILL BE DAMAGED.

3 TIGHTEN SCREWS.

1. Carefully install module protection plate per FCO instructions. This requires insertion of the plate under existing wire runs which can be easily broken.
2. Run maindecs or other programs whose failure indicates the need for this FCO to be implemented. They should now function correctly.

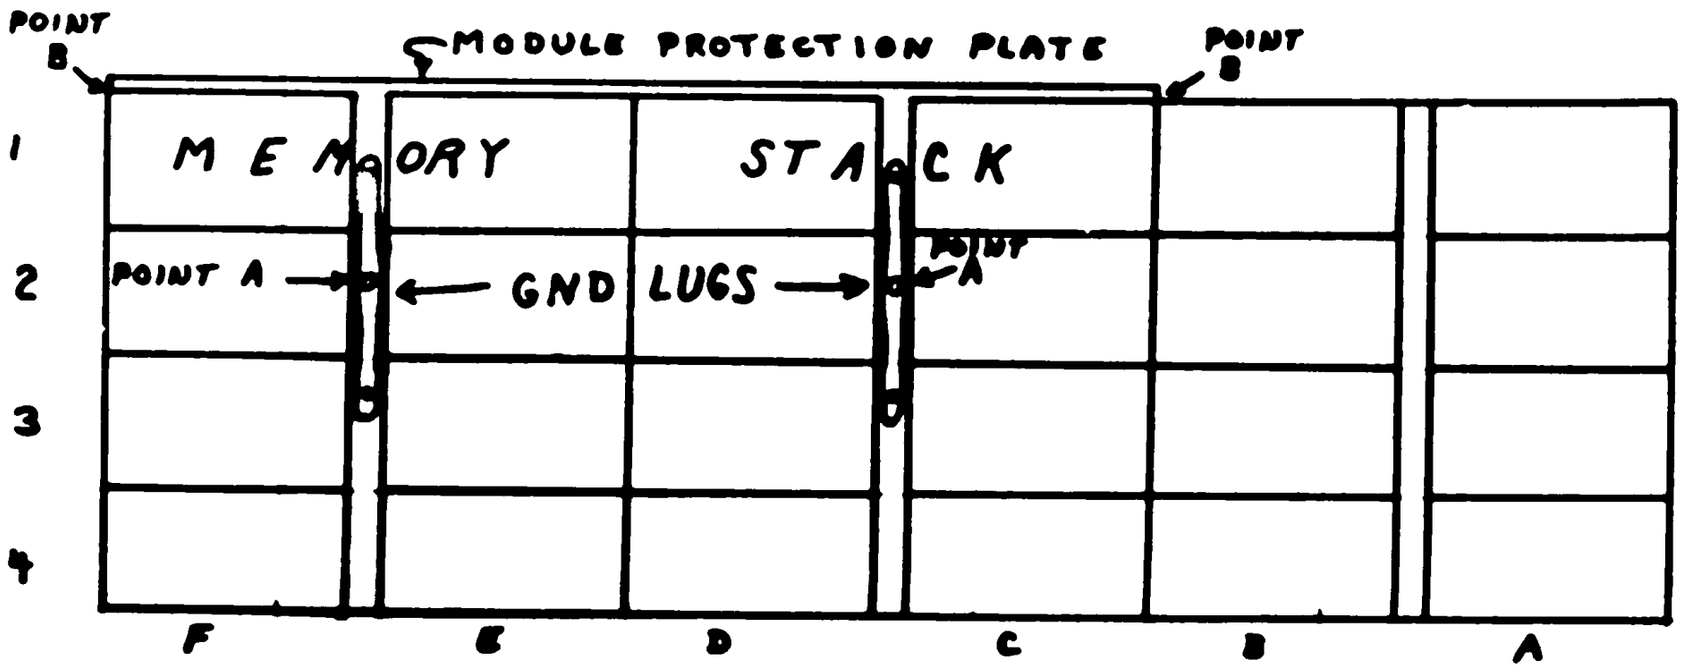
Under some conditions when other options are placed along side an MM11/S they fail to operate correctly.

1. LOOSEN 2 SCREWS AT POINTS A. CARE SHOULD BE USED AT ALL TIME SO THAT NO WIRES ARE DAMAGED.
2. SLIDE THE FINGERS OF THE MODULE PROTECTION PLATE UNDER THE GND LUGS. THE PROTECTION PLATE SHOULD BE RIGHT AGAINST THE WIRED ASSY. FRAME, POINT B.
3. TIGHTEN SCREWS.
